MARINE SAFETY INVESTIGATION
REPORT 148

the shift of cargo on board the Singapore flag bulk carrier

PADANG HAWK

Australian Transport Safety Bureau

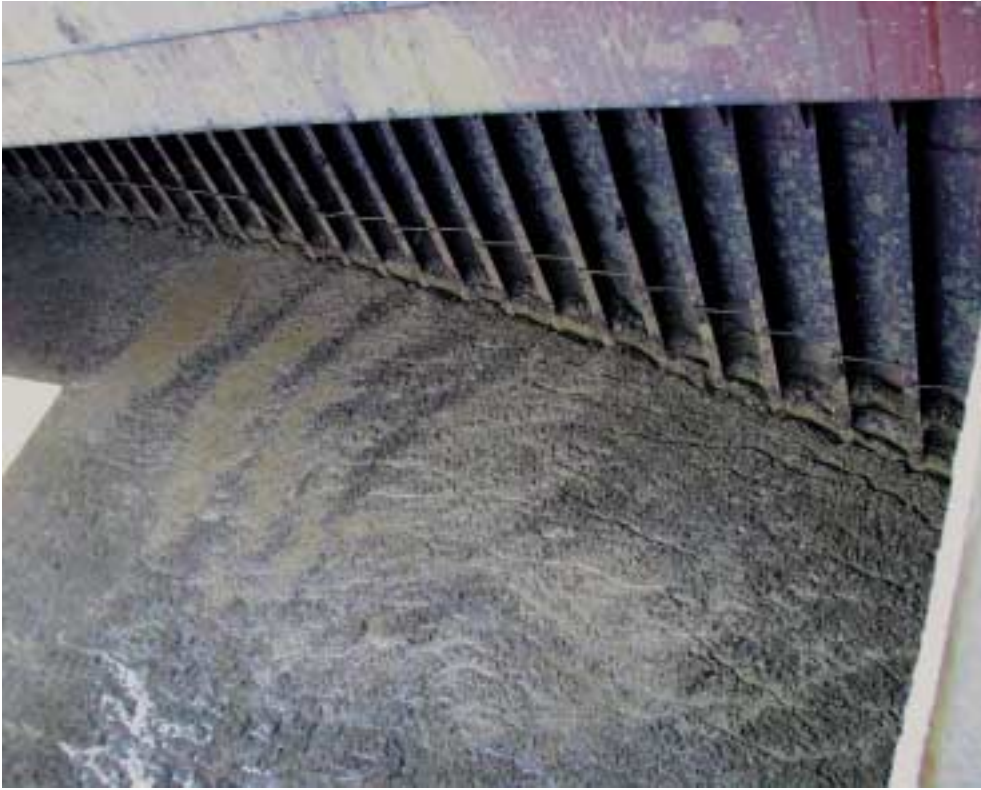
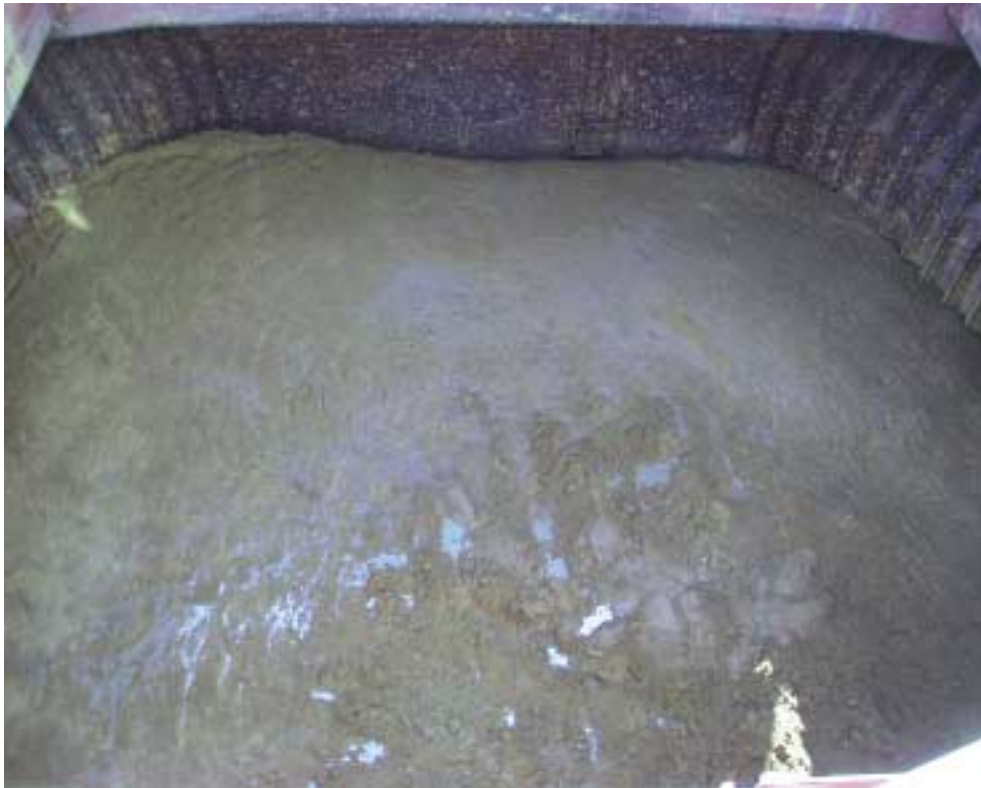
FIGURES 6 & 7
Cargo, hold number 1 (two views)

Some water was pooling on the surface of the cargo in number 1 hold. The cargo in the forward holds appeared to be ‘flowing’ with the movement of the ship.

The master sent the mate, boatswain and some deck ratings to check the hatches and the state of the main deck. The crew checked and found the cargo hatches and the small hold access hatches secured. They opened an access hatch to each of the holds in turn. They found that the cargo in all but number 5 hold had settled and shifted to port. The cargo in the first 3 holds appeared to be semi-liquid, 'like melted ice cream' as the boatswain described it.

Nickel ore has not been considered to be prone to liquefaction. This cargo is regularly carried with total moisture contents in excess of 36%. On this occasion, however, the cargo in Padang Hawk’s 1, 2, 3 and 4 holds had every outward appearance of having suffered ‘liquefaction’ during the voyage.

At some time during voyage number 904, despite the fact that the crew pumped the hold bilges regularly and effectively on 24, 25 and 26 July, a portion of Padang Hawk's nickel ore cargo liquefied and moved to port causing the vessel to list. After listing to port on the evening of 26 July, the crew inspected the cargo holds and observed the cargo flowing with the movement of the ship. On arrival in Townsville the cargo in the forward four holds displayed clear evidence of liquefaction in the fluid form of the cargo and the free water present on the surface of the cargo in number 1 hold. The varying degree of liquefaction of the cargo, with the forward holds being the most affected, may be explained by the motion of the ship in the rough sea. Padang Hawk was pitching and rolling heavily on 25 and 26 July. All of the cargo would have been similarly effected by the rolling. However, the amplitude of the pitching, and thus its effect on the cargo, would have been greater at the forward holds. The cargo in
